NARRAGANSETT BAY BASIN  
WEST WARWICK, RHODE ISLAND  
**ARCTIC DAM**  
**RI 03802**

PHASE I INSPECTION REPORT  
NATIONAL DAM INSPECTION PROGRAM

JANUARY 1981

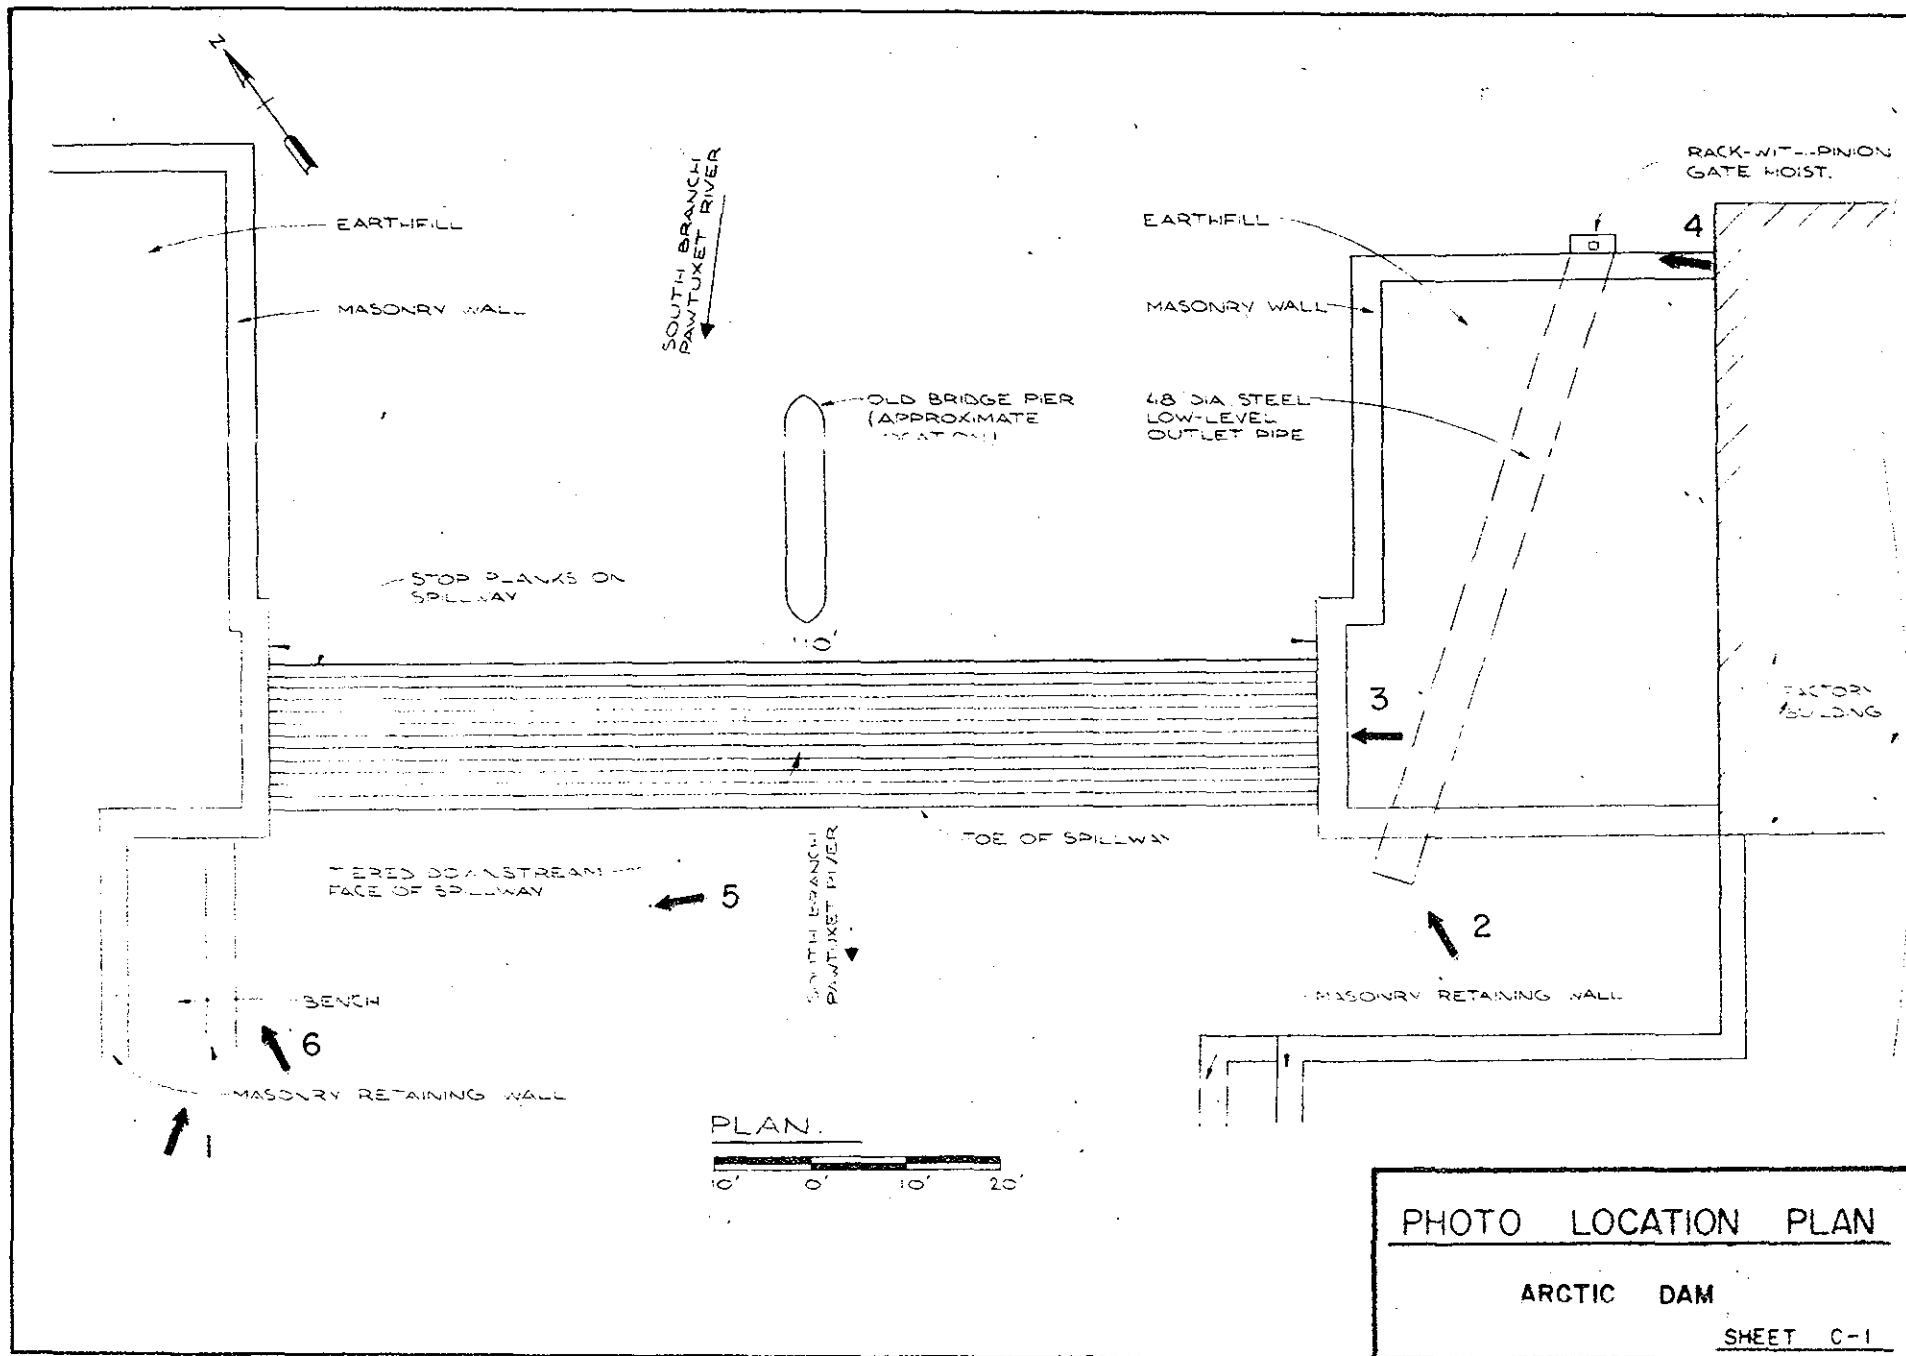
Top of Dam - The top of the right non-overflow section is in good condition, with a regular surface and good grass cover (Photo 1). A wooden railing on top of the masonry wall and extending from the upstream edge of the dam to the bridge 100 feet downstream of the dam is in fair condition, with slight rotting of the wood.

Photo 1 - Right non-overflow section of dam and adjacent factory building (10/8/80).
